# Remedial Investigation Report

**Eighteenmile Creek Corridor,  
Lockport, Niagara County, New York  
Site Number 932121**

**September 2006**

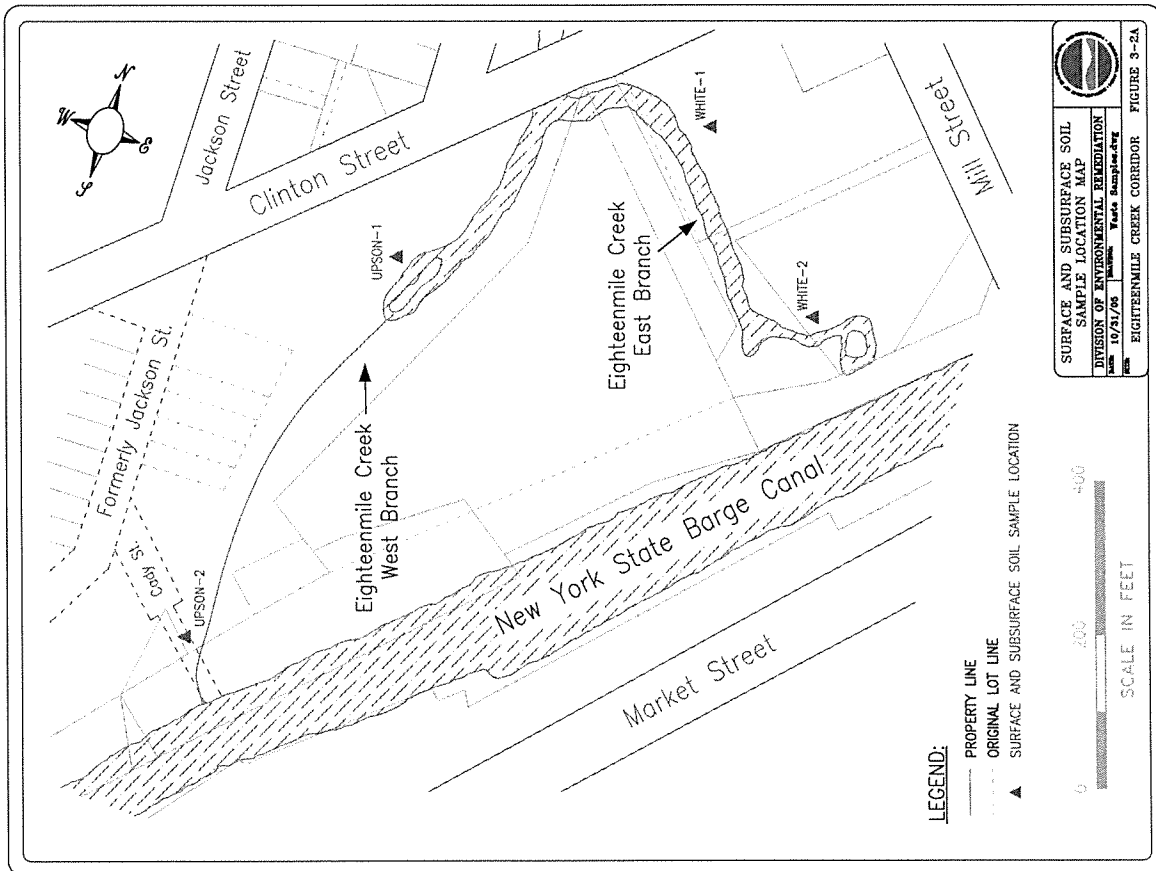
During the property inspections, fill material was observed on the Upson Park property in the embankment along Eighteenmile Creek. This material was a reddish-brown, ash-like fill containing glass, metal fragments, brick fragments, rubber and buttons. As a result of this finding, surface and subsurface fill samples were collected from two locations in the park during the Remedial Investigation. The locations of these samples are shown on Figure 3-2A. These samples were collected to determine if the fill material was a potential source of contaminants to Eighteenmile Creek. All four samples were submitted to Severn Trent Laboratories for chemical analysis of semivolatile organic compounds, PCBs and metals (Table 3-1). The analytical results for these samples are summarized in Table 5-12.

Figure 5-8. Closeup photograph of the ash-like fill along the north bank of Eighteenmile Creek in Upson Park. Photograph taken by Glenn May on September 22, 2005.
