# **Evaluation of Sediment Quality of the Erie Canal between the Niagara River and Rochester, New York**

**New York State Canal Corporation**

January 2000

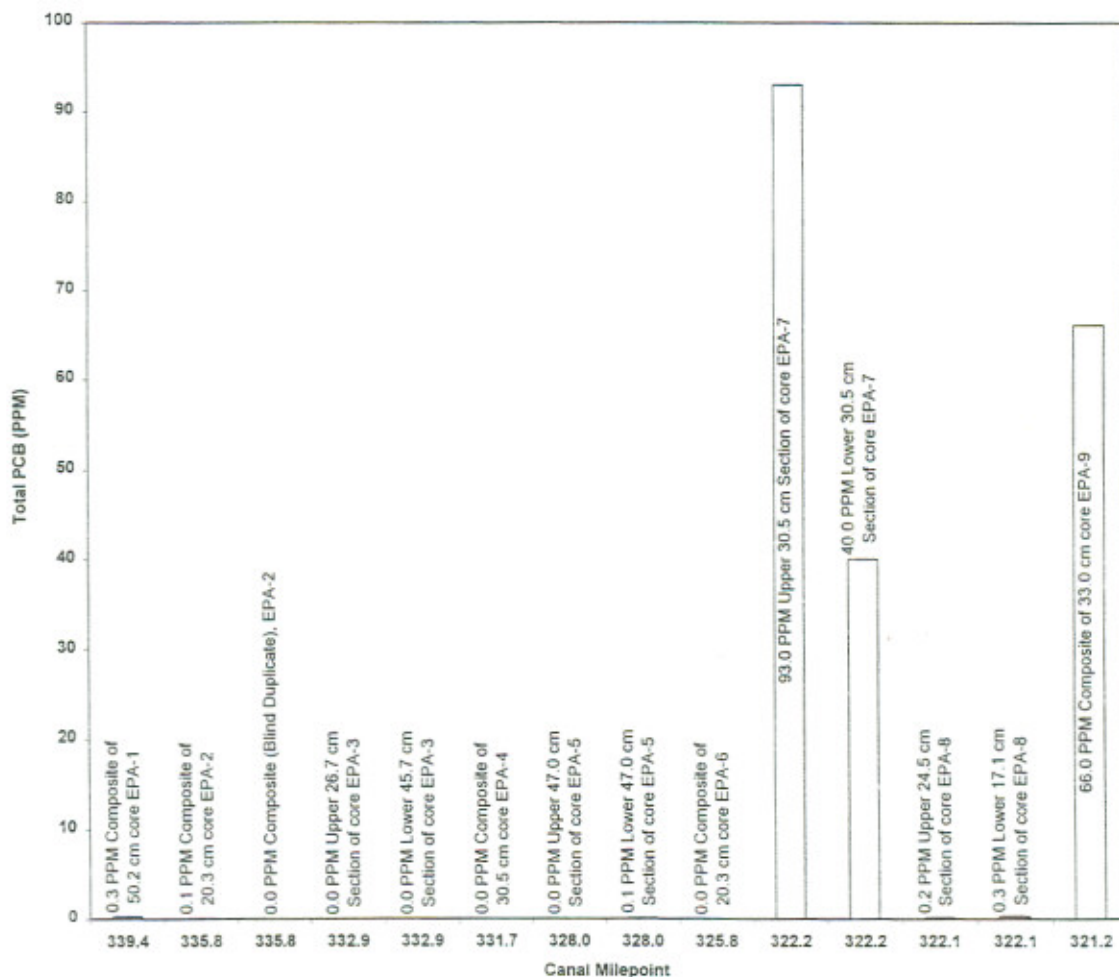
Figure # 4.1  
Total PCB Concentration in Reach # 1

centimeter core was collected and composited. The concentration of PCB within this core, which represents a composite of the upper 33.0 centimeters of sediment, was 66 PPM. The geometry of the canal at this point is quite wide and there is little to no flow velocity during canal operations. Based on observations of this location on the canal during the navigation season, it appears that the increased sediment depth and the elevated total PCB concentrations found at this sampling location are due to the low flow velocities in this area. Based on the above results it appears that a source of the PCB contamination exists in the vicinity of milepoint 322.2.

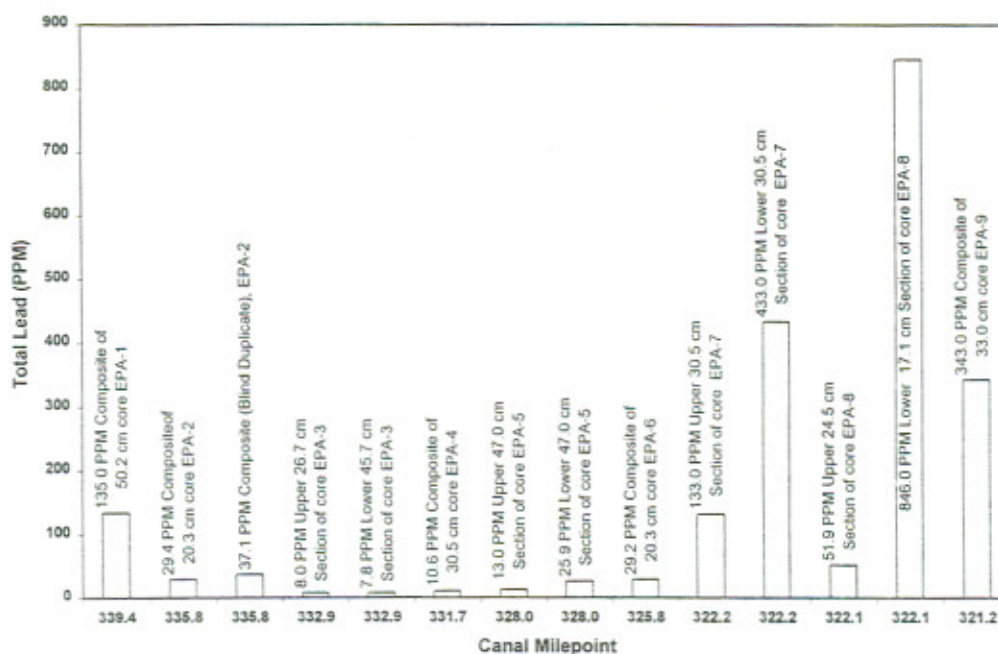
**Figure # 4.2**  
**Lead Concentration in Reach # 1**

The cores collected and the sections obtained within reach 1 were also analyzed for total lead. What is curious about this group of samples is the elevated levels that are seen in sample EPA-1 which exhibited the concentration of 135.0 PPM. This sample was collected at the confluence of the canal and the Niagara River; it is unknown what the source of this elevated lead level could be since it could represent upstream contaminants in the Niagara River. The core collected at sample site EPA-7 showed a level of 133.0-PPM total lead within the upper section of the core while the lower section was significantly elevated to a level of 433.0 PPM. This phenomenon is also evident at sampling site EPA-8 where the upper 24.5 centimeters of the core showed a lead concentration of 51.9 PPM while in the lower 17.1 centimeters of the core showed a lead concentration of 846.0 PPM. This leads me to believe that the rate of lead contamination within the canal may have subsided over time. At sampling site EPA-9 lead concentration of the composited 33.0 centimeter core was 343.0 PPM. Of note is that sample site EPA-7 is almost underneath the Prospect Street Bridge while the both EPA-8 and EPA-9 is downstream of this bridge. This structure has been closed for numerous years due to its deteriorated condition and most likely contains lead-based paint. Figure # 4.2 below provides a graphical representation of the lead concentration within this reach.

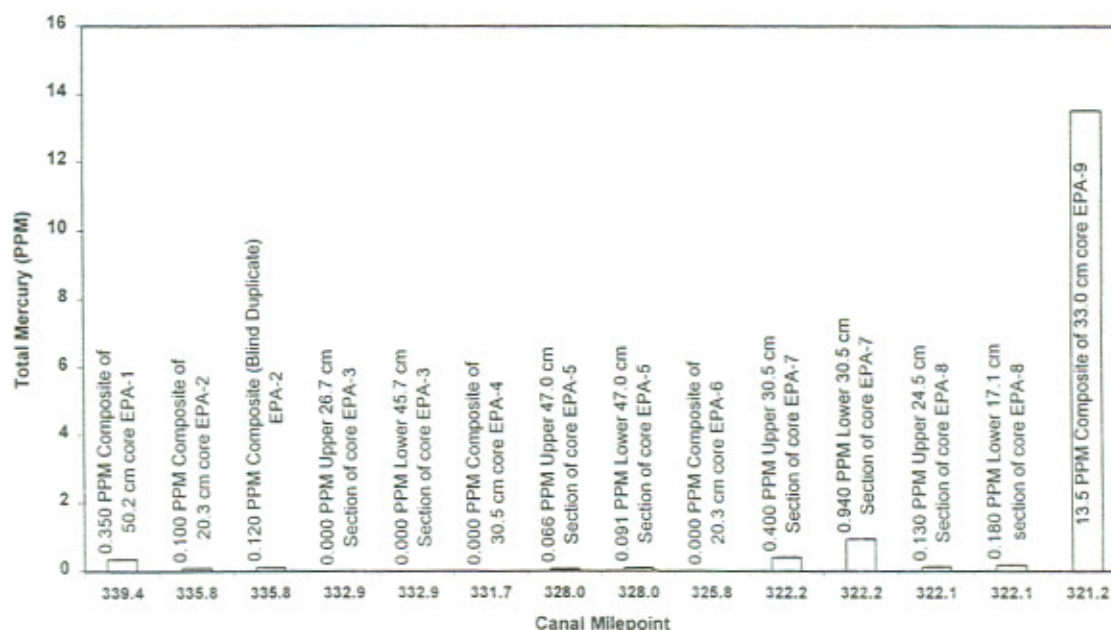
**Figure # 4.3**  
**Mercury Concentration in Reach # 1**

Within this reach only three areas are of interest when one looks at mercury contamination in the sediments; there is an elevated level (0.350 PPM) at sample site EPA-1, most likely attributable to contaminants in the Niagara River. Elevated levels are also detected at sample site EPA-7. The upper section exhibits a level of 0.400 PPM while the lower core section contains 0.940 PPM mercury. The significant difference between upper and lower sections suggests that contaminant levels are decreasing in the more recent sediment deposits. The most surprising mercury contaminant concentration identified was at sampling site EPA-9 where the level of 13.5 PPM was identified within the top 33.0 centimeters of the sediment. It is unclear whether there is a supplemental source of mercury to the system or if the effects of low flow velocity have contributed to this elevated concentration. A third possibility is that the results of this sample may not accurately represent the mercury concentrations in the sediment in this area. Supplemental sampling is suggested to verify the presence of elevated Mercury levels. Figure # 4.3, below show levels of mercury contamination within the sediments plotted on an axis of canal milepoint.

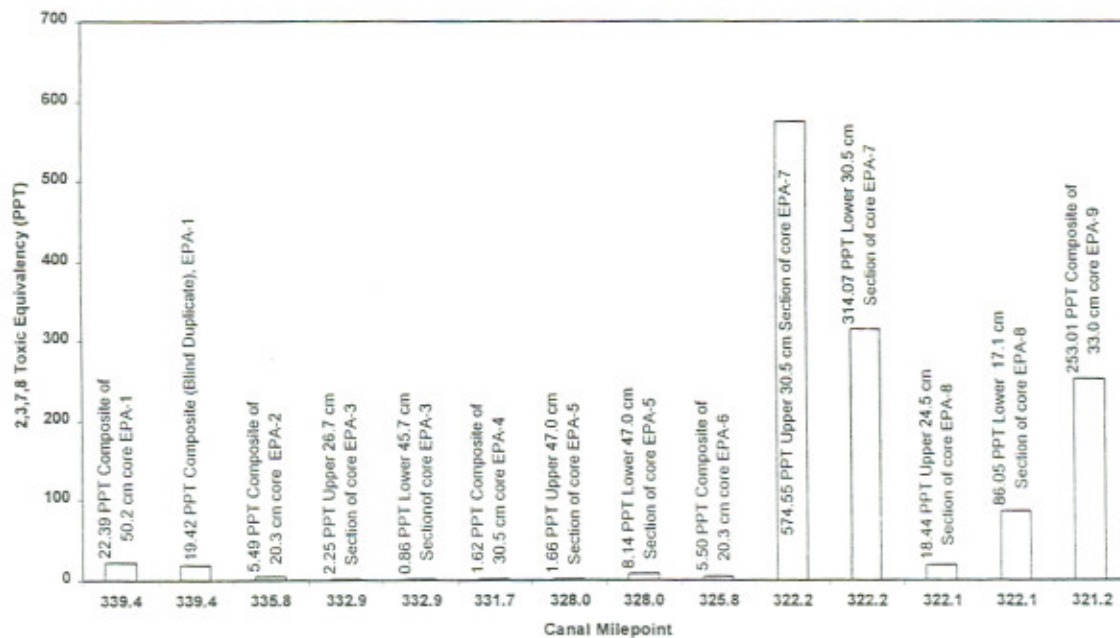
**Figure # 4.4**  
**Dioxin/Furan TEQ in Reach # 1**

The results of the dioxin/furan analyses evaluated on a TEQ basis are similar to the trend seen in PCB contamination. There is a slight elevation of dioxin TEQs apparent at sample site EPA-1; the level appears to be consistent with the level of this contaminant encountered in numerous other locations along the canal in western New York. A significant TEQ concentration in the upper section at sample site EPA-7 of 574.55 PPT compares with a level of 314.07 PPT within the lower section of this core. Based on the above results, it appears that quite possibly the source of PCB contamination may also be the source of the dioxin/furan contamination in the vicinity of milepoint 322.2, near the Prospect Street Bridge. At sample site EPA-8 the trend reverses itself where the upper core section is at 18.44 PPT while the lower section is 86.05 PPT on TEQ basis. At sample site EPA-9, the levels of Dioxin/Furans on TEQ basis within the sediment composited from a 33.0 centimeter core is 253.01 PPT.

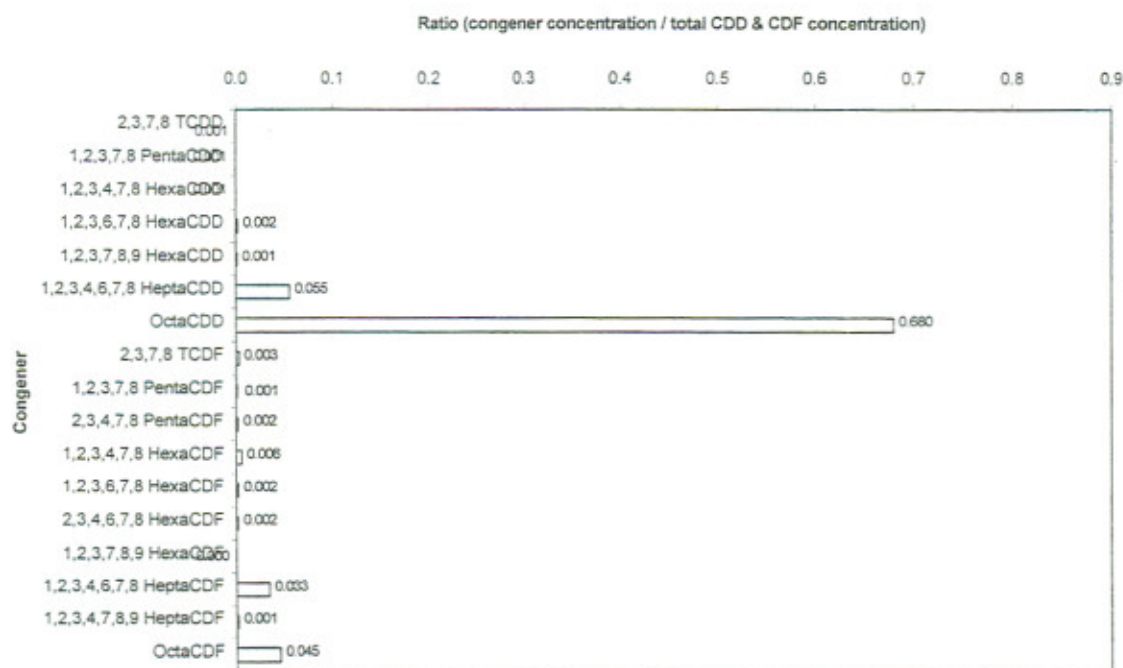
**Figure # 4.5**  
**Congener Profile - Reach Number 1**  
(without core EPA-3)

Both the upper and lower core sections within Reach Number 1 exhibit the same trend in congener profile with the exception of sampling site EPA-3. The general congener profile for the sediments within this reach are shown in Figure # 4.5.

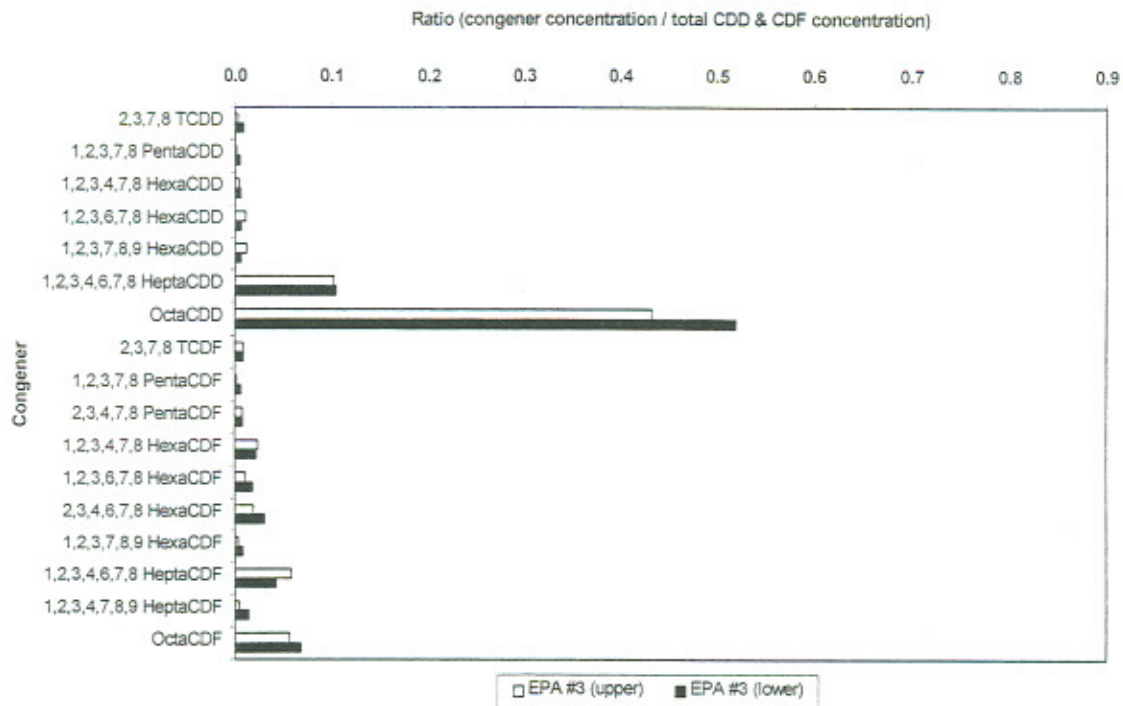
**Figure # 4.6**  
**Congener Profile Milepoint 332.9 (EPA #3)**

Sample site EPA-3 has a different congener profile in both the upper and lower core sections than any of the other samples from this reach. There are significantly increased levels of 1,2,3,4,6,7,8 Heptachlorodibenzodioxin along with slightly elevated levels of all of the Pentachlorodibenzofurans and Hexachlorodibenzofurans and 1,2,3,4,7,8,9 Heptachlorodibenzofurans. There is about a 20 percent decrease in the percent of Octachlorodibenzodioxin within the sample results. It is currently unknown if this shift in congener pattern might identify a different source or quite possibly an area where biotic or abiotic degradation has caused a decrease in the more highly chlorinated congeners within the upper sediments. These sediments are also closer to the surface of the water column, hereby allowing for photo-degradation from sunlight (photolysis). Figure # 4.6 following, shows the congener patterns observed in core EPA-3.

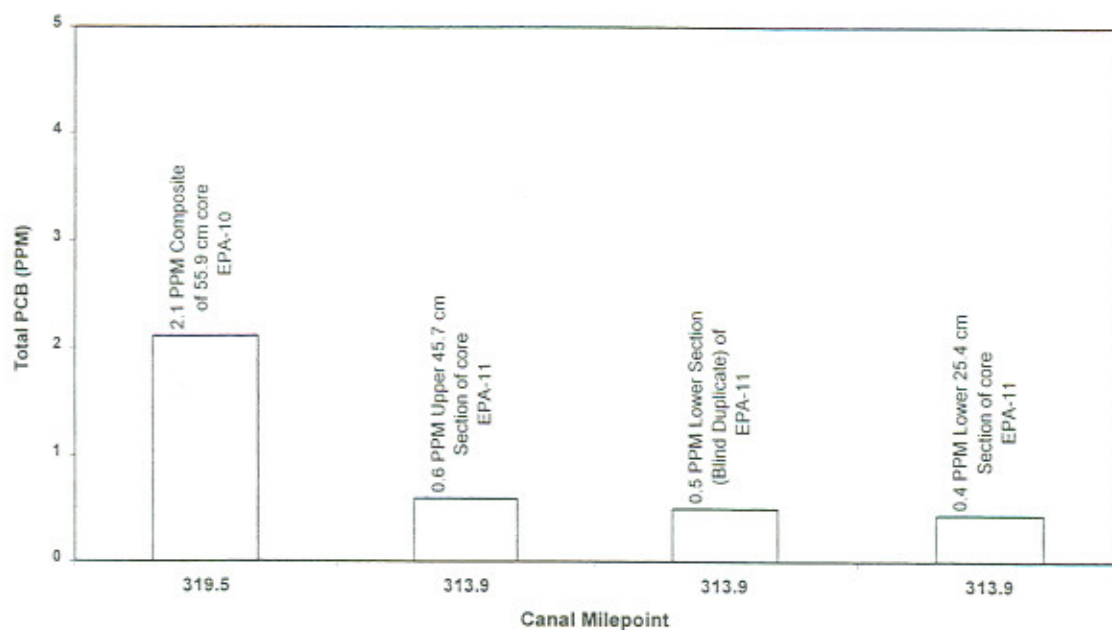
**Figure # 4.7**  
**PCB Concentration in Reach # 2**

The levels of PCBs in the lower section of the core contained PCBs in a concentration of 0.4 PPM as shown on Figure # 4.7, below.

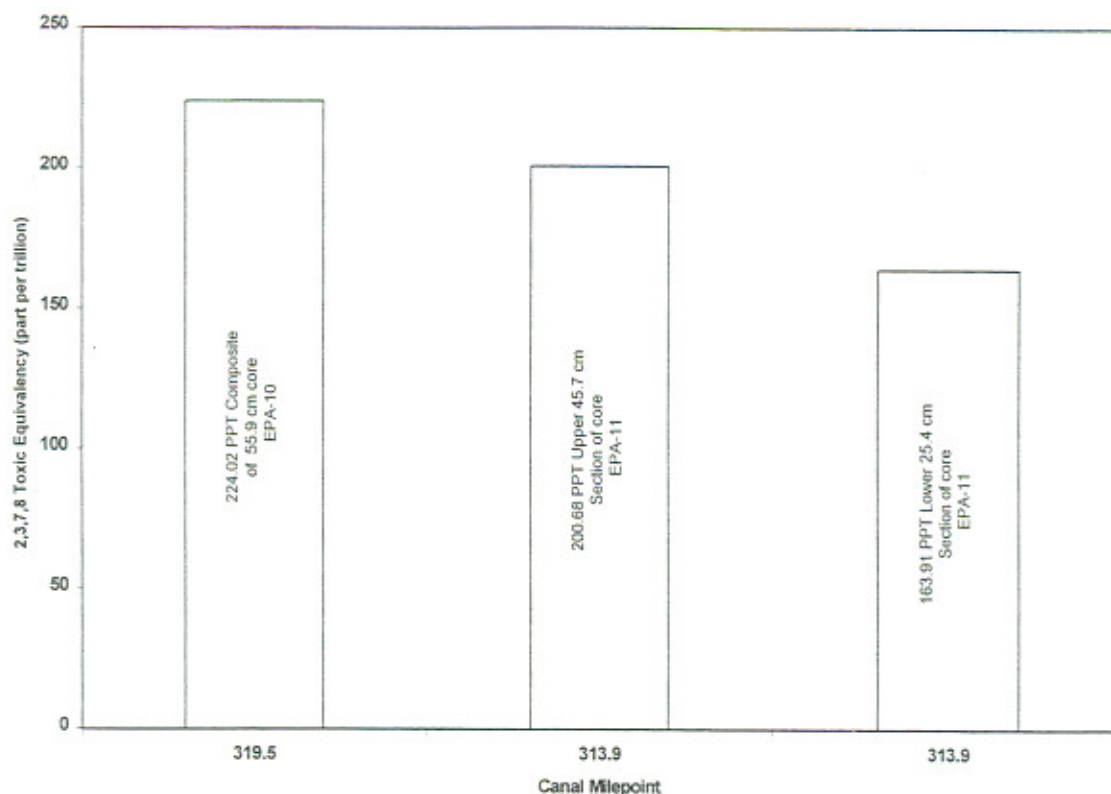
Figure # 4.8  
Dioxin/Furan TEQ in Reach # 2

Dioxin/furan analyses evaluated on a TEQ basis trend downward as you move from Lockport eastward. The TEQ concentration measured in the composite of the core collected at sampling site EPA-10, 224.02 PPT is less than the TEQ levels encountered in the Lockport area. The upper section obtained at sample site EPA-11 of 220.68 PPT is only slightly elevated above the level of 163.91 PPT found in the lower section of this core. Dioxin/Furan TEQ concentrations are shown below on Figure # 4.8.

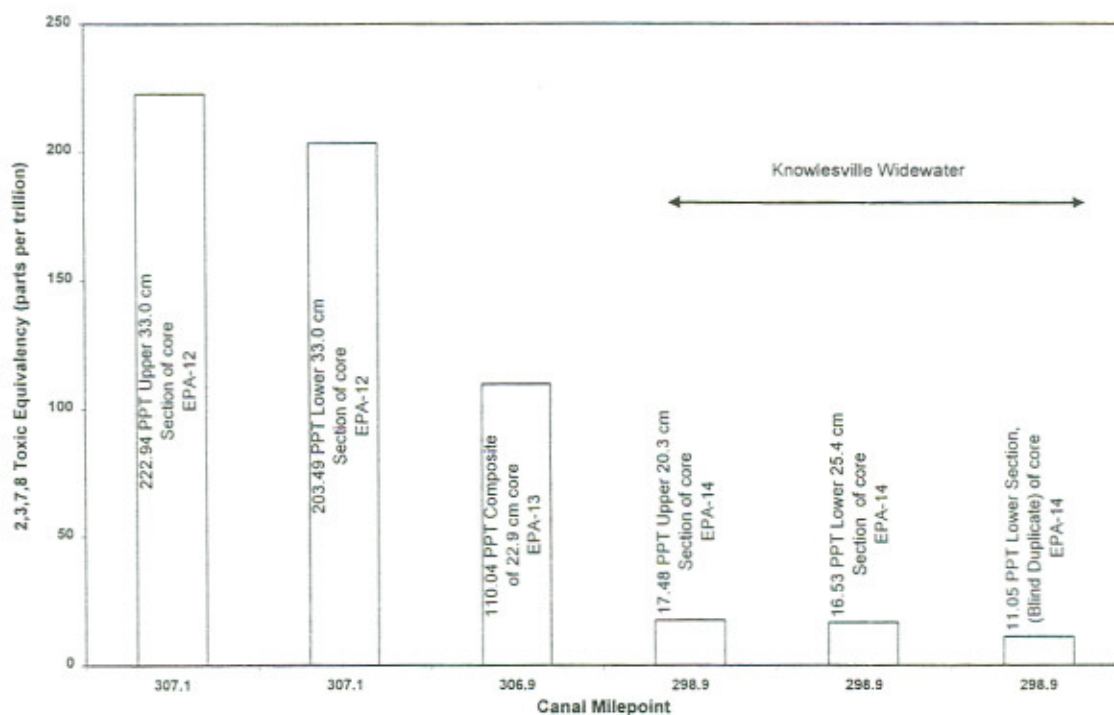
Figure # 4.10  
Dioxin/Furan TEQ in Reach # 3

Dioxin/Furan TEQ levels in this reach trend downward as you move easterly. Core samples collected at sample site EPA-12, milepoint 307.1 are generally the same as the levels found in reach number 2. At this location there is little difference in TEQ concentration between the upper and lower sections of the core. A composite from sample site EPA-13, milepoint 306.9 is nearly half of the levels seen at milepoint 307.1. Samples collected at sample site EPA-14, milepoint 298.9 were collected in a very large

widewater area. This location appears to have seen little contaminant impact due to its location. Figure # 4.10, below shows the TEQ concentrations encountered within this reach.

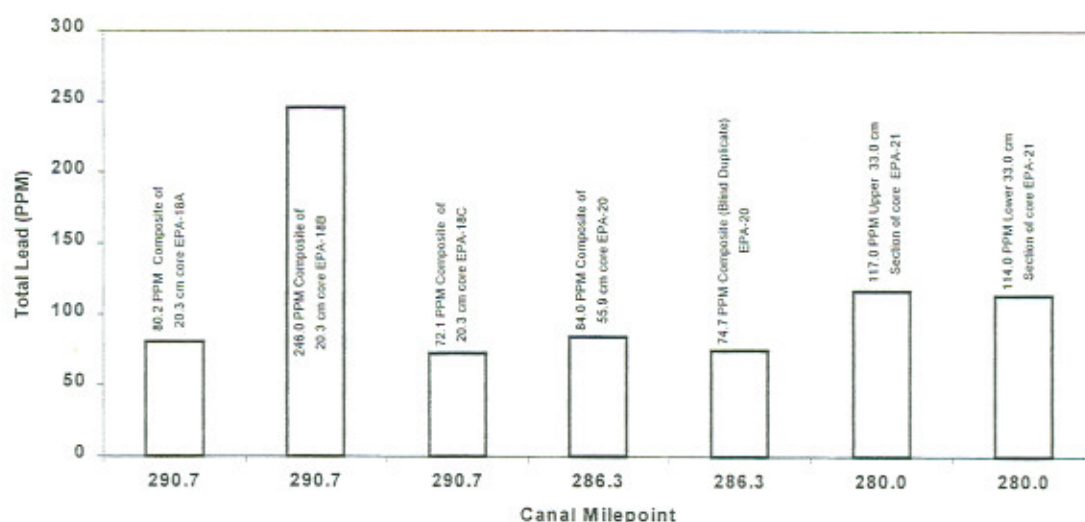
**Figure # 4.11**  
**Lead Concentration in Reach # 4**

Within this reach 5 push cores were collected, 3 were taken from the upper 20.3 centimeters of sediment to evaluate the surface sediment quality adjacent to a bridge. The levels of PCB contamination encountered in the sediment were non-detectable within this reach. Sample sites at EPA-18A, milepoint 290.7 represents the conditions 33 meters upstream of the Orleans County Rote 11 Highway bridge, site EPA-18B was collected 2

meters from the downstream side of the bridge span and EPA-18C was collected 20 meters downstream. Many were small in length since there is limited sediment within the main channel of the canal. The elevated levels exhibited at sample sites EPA-20 and EPA-21 can not be accounted for since they are quite some distance from structures crossing the canal. It is hypothesized that the lead level detected may have been caused by the downstream transport of paint flakes. Figure # 4.11 shows the lead concentrations within this reach of the canal.

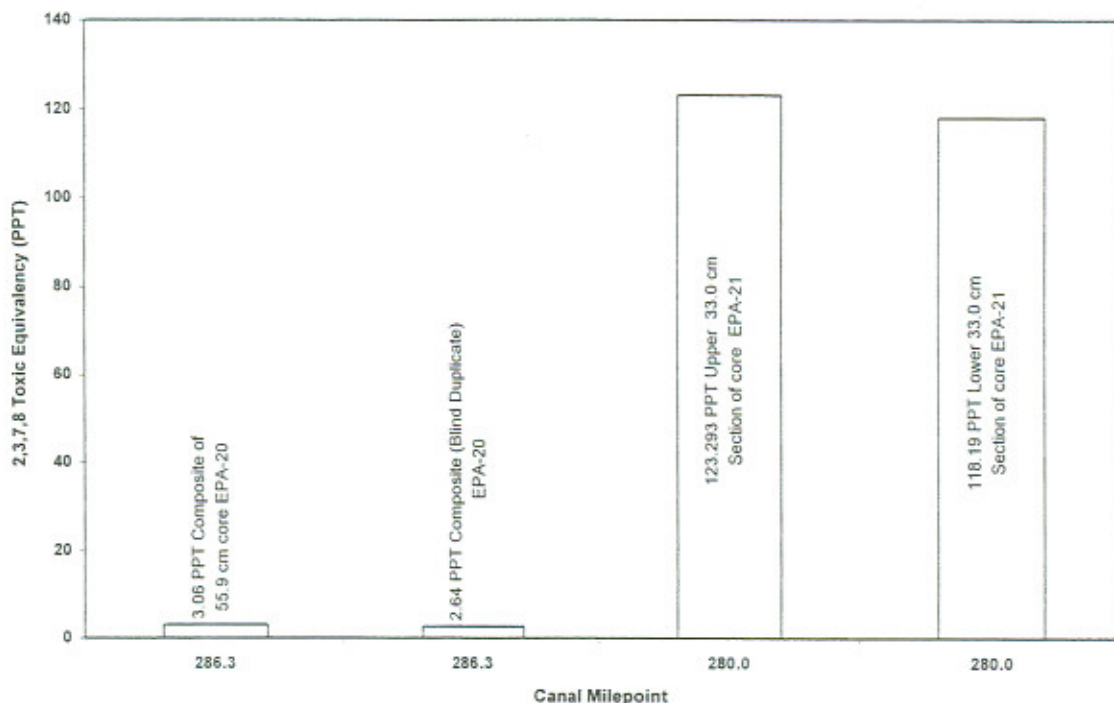
Figure # 4.12  
Dioxin/Furan TEQ in Reach # 4

As discussed for reach number 3, the Dioxin/Furan TEQ levels are generally trending downward as one moves easterly. Core samples collected at sample site EPA-20, milepoint 286.3 show a level that is substantially lower than have been observed to the west. The location for this sample site was within an area of the canal of standard cross-section, where there would be little deposition of contaminants over time. Samples collected at sample site EPA-21, milepoint 280.0 were collected in a relatively wide area of the canal, on the outside of a curve. Dioxin/Furan TEQ levels are generally the same as those found in the western end of reach number 3. At this location there is little

difference in TEQ concentration between the upper and lower sections of the core. Figure # 4.12, below shows the TEQ concentrations encountered within this reach.

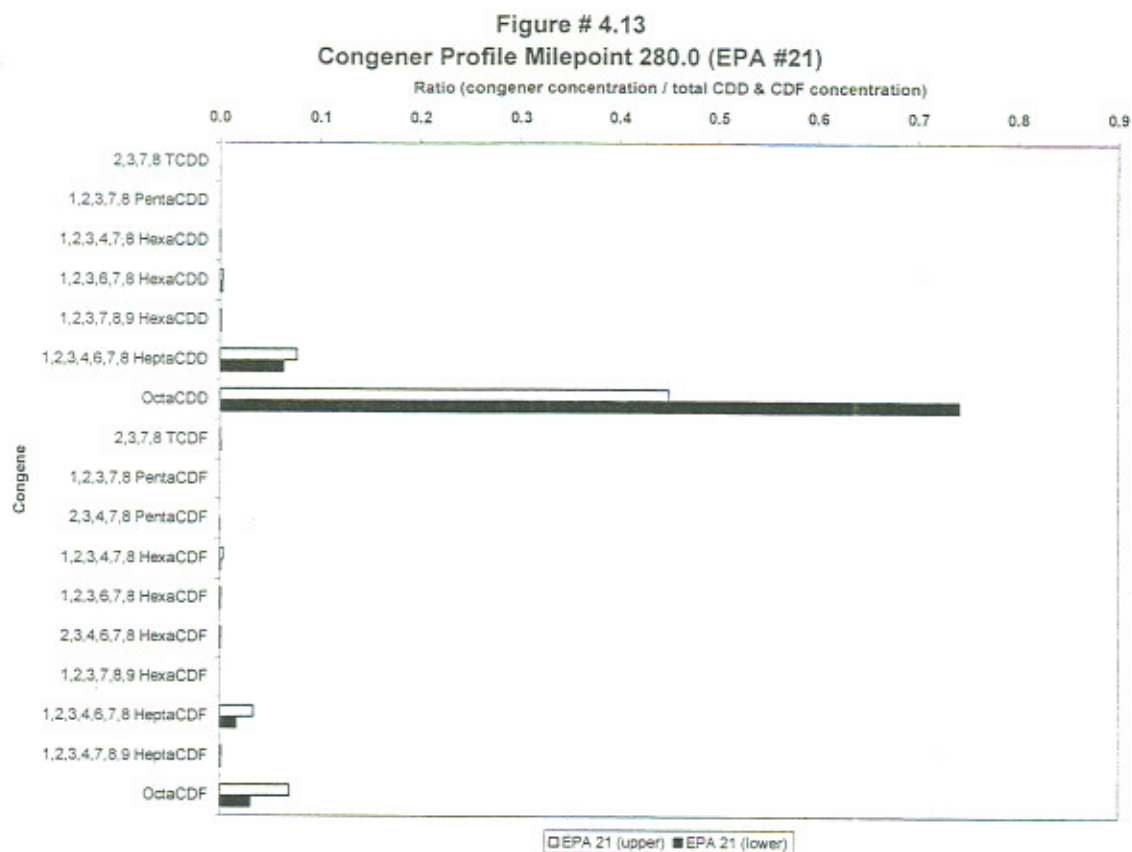
The composite core collected at sampling site EPA-20 and the lower core section of the core collected at sampling site EPA-21 exhibit the same congener profile, similar to the profile seen within all of the western canal reaches. In the upper section of sampling site EPA-21 there is a significant reduction in the Octachlorodibenzodioxin with a corresponding increase in the concentrations of 1,2,3,4,6,7,8 Heptachlorodibenzodioxin, 1,2,3,4,6,7,8 Heptachlorodibenzofuran and Octachlorodibenzodioxin. There is no known reason for this shift in congener pattern. Figure # 4.13 following, shows the congener patterns observed both the upper and lower sections of core EPA-21.

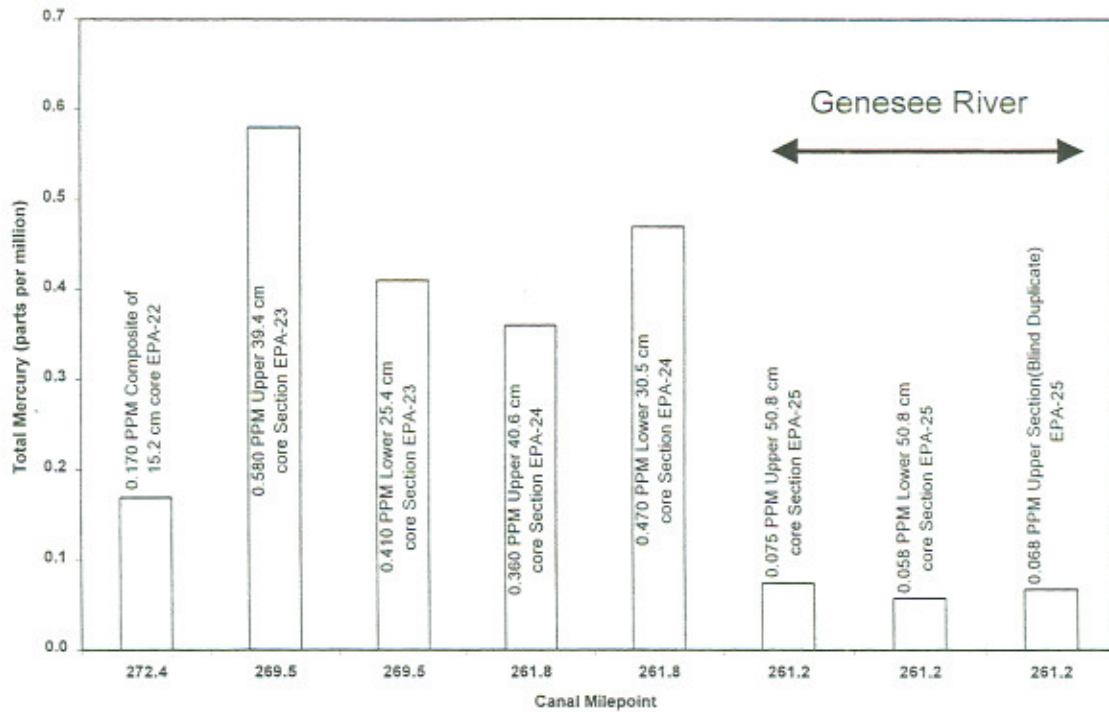
Figure # 4.14  
Mercury Concentration in Reach # 5

Four push cores were collected within this reach, 3 were sectioned based on characteristics of the sediment while the fourth core was composited over its entire length. The levels of PCB contamination encountered in the sediment within this reach ranged from 1.05 PPM to non-detectable. The concentration of mercury in the sediment shows the dilution effects of the confluence of the canal with the Genesee River in Rochester. The levels of total mercury within the Genesee River downstream of the confluence are nearly an order of magnitude below the levels seen in the canal sediments. Since the flowrate in the canal represents only a small share of the combined flow, the dilution effects can be clearly seen in Figure # 4.14.

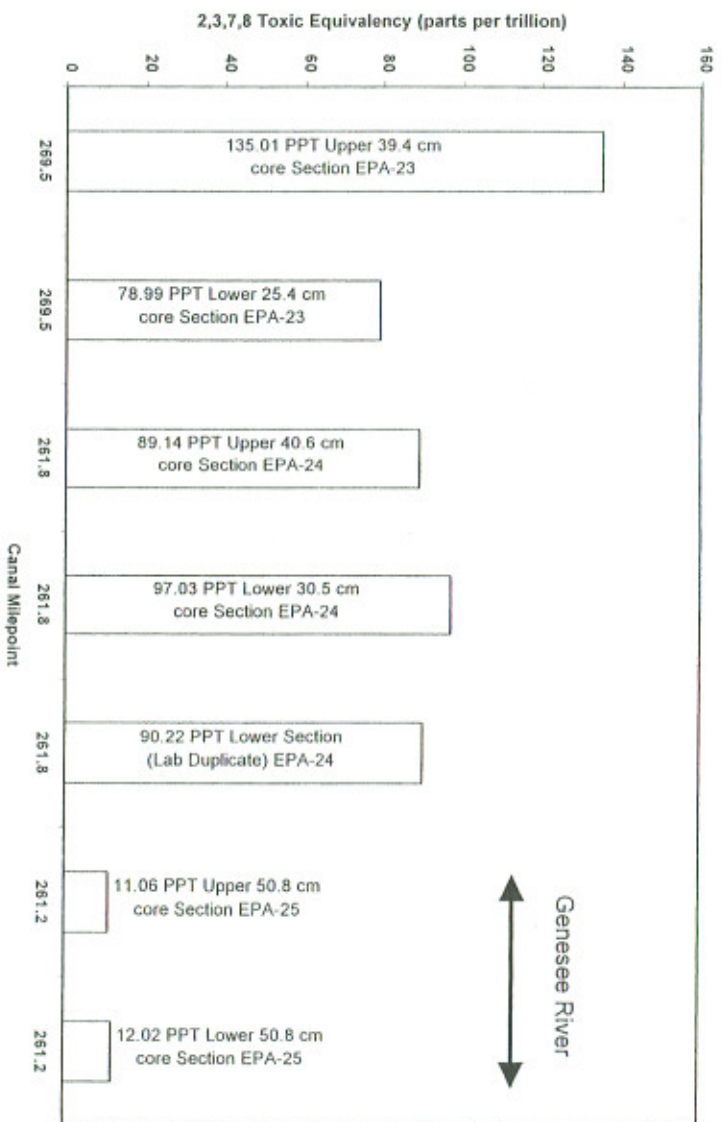
Figure # 4.15  
Dioxin/Furan TEQ in Reach # 5

The dilution effects on the dioxin/furan TEQ concentrations are also evident by being nearly an order of magnitude less than the levels encountered in the canal sediments upstream of the confluence of the Genesee River. In sediments that were evaluated prior to the confluence the level of dioxin/furan TEQ continues to show the downward trend when moving from west to east along the canal. The levels within the sediment are approximately 1/5 of the TEQ levels found in the Lockport, New York area, with little change in the congener pattern. Figure # 4.15, below shows the dioxin/furan TEQ concentrations within this reach.

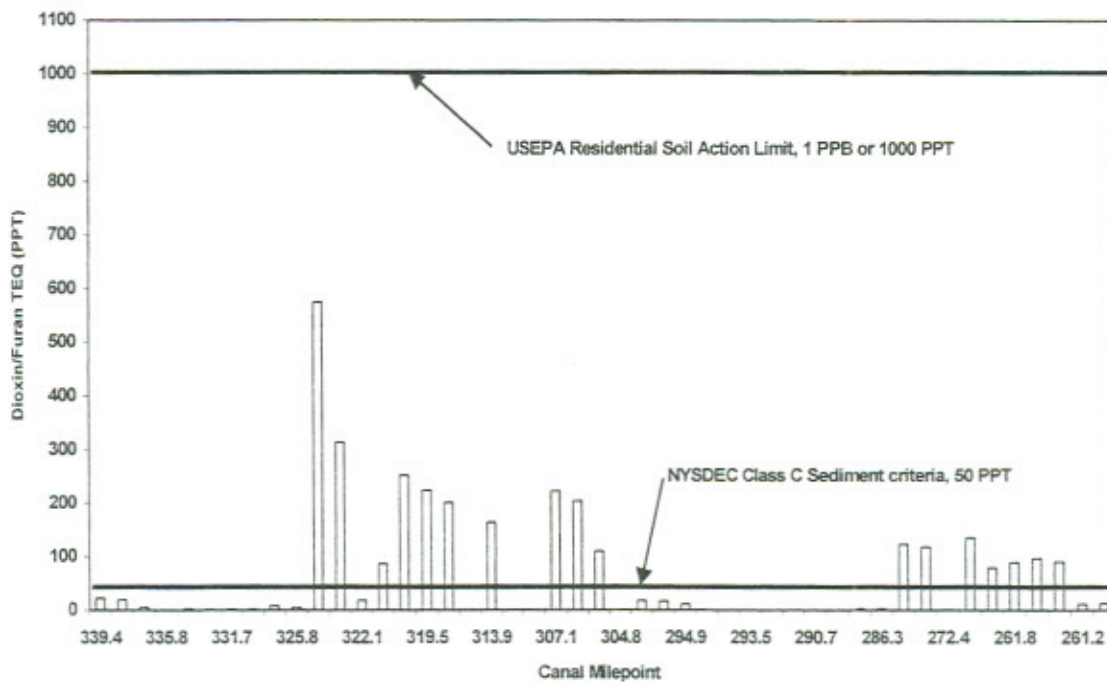
Figure # 5.1  
2,3,7,8 Substituted Dioxin/Furan TEQ Levels in Sediments

Elevated levels of dioxin/furan contamination were encountered within the sediments under the Prospect Street Bridge in Lockport and are detectable in the sediments all the way to the Genesee River in Rochester. In some locations the 2,3,7,8 substituted TEQ levels exceed the NYSDEC Class C Sediment criteria of 50 ppt [6]. In no case does the level of 2,3,7,8 TCDD TEQ found in the sediment exceed the USEPA residential soil action limit of 1 PPB [8] or the NYSDEC Technical and Administrative Guidance Memorandum allowable soil concentration of 6 PPB [9].

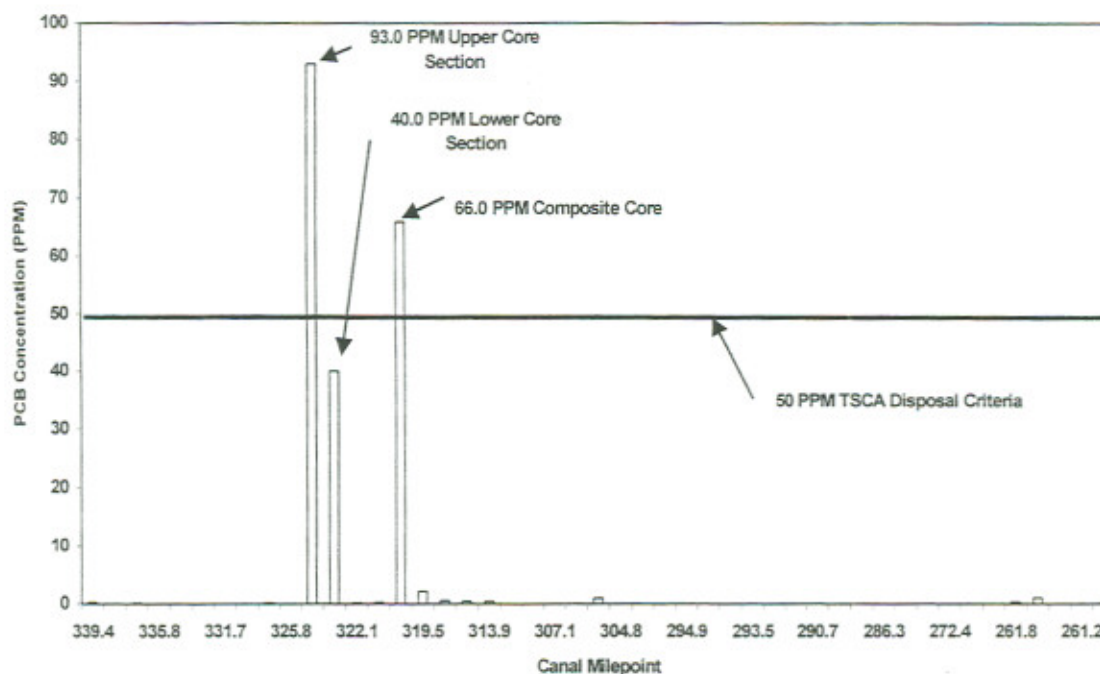
**Figure # 5.2**  
**PCB Concentration in Sediments**

Elevated PCB levels are apparent in the Lockport area originating in the same area as the dioxin/furan contamination but do not seem to be spread as widely to the east.

Two locations showed levels of total PCB that exceeded the TSCA disposal criteria of 50 PPM. These two areas should be further sampled to determine the extent of the contaminated area.

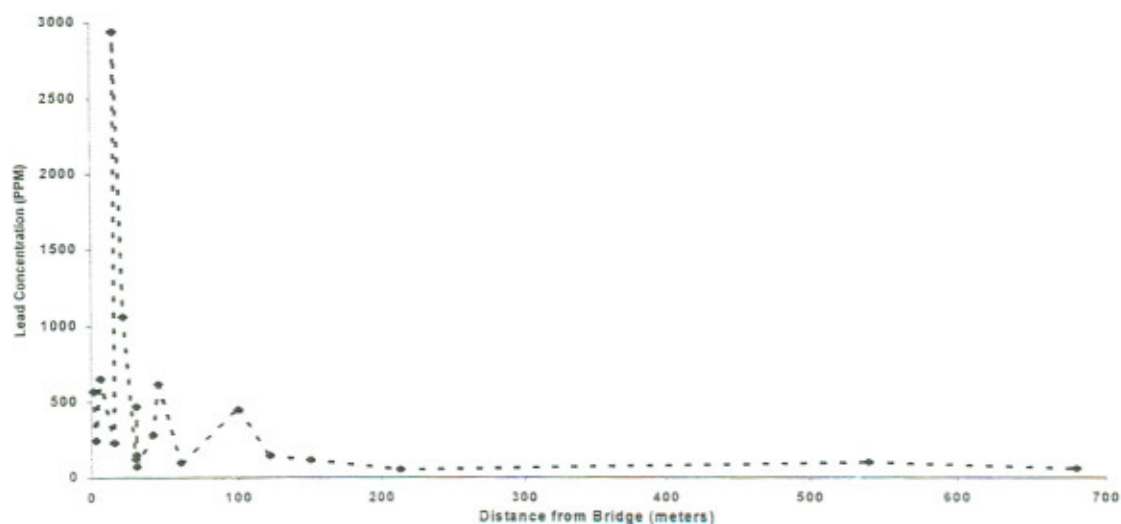
**Figure # 5.3**  
**Lead Concentration Downstream of Bridges**

Although the amount of data points that are used to prepare the above figure and analysis may be somewhat limited, it is clear that particulate lead has caused an impact on the canal sediments. Supplemental data collection will be continued to better define the trend in sediment contamination.

- There is a general trend of increased lead concentrations downstream of bridges that cross the canal. Past activities of bridge washing and abrasive blasting prior to painting may be the cause of this contamination. Additional detailed sediment sampling should be conducted before and after bridge maintenance functions to determine if these activities are impacting sediment quality. Subsequent benthic testing of the sediments may be warranted.

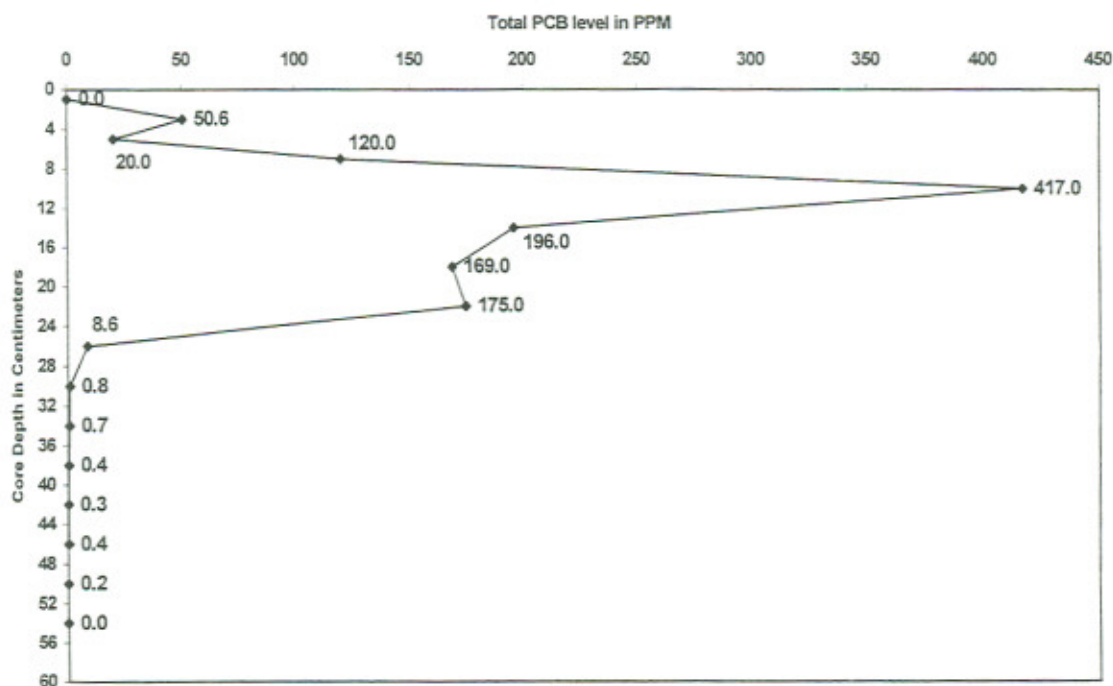
**Figure # 5.4**  
**Core EPA 7 - Total PCB Profile**

The information that is provided by this profile is quite dramatic, the initial detection of PCB that appears significant in the sediment appears in the 24 to 28 centimeter depth. Based on extrapolation this sediment horizon is estimated to have been deposited in approximately 1958. The low level of PCB detection that occurs in the 28 to 52 centimeter range are believed to be remnants of sediment from upper layers of the core, smearing within the core tube while the core is being pushed into the sediment. More significant discharges appear to have occurred in the 1961 to 1979 era with a more

peak discharge apparent in the 8 to 12 cm range, which would correspond to approximately 1982.

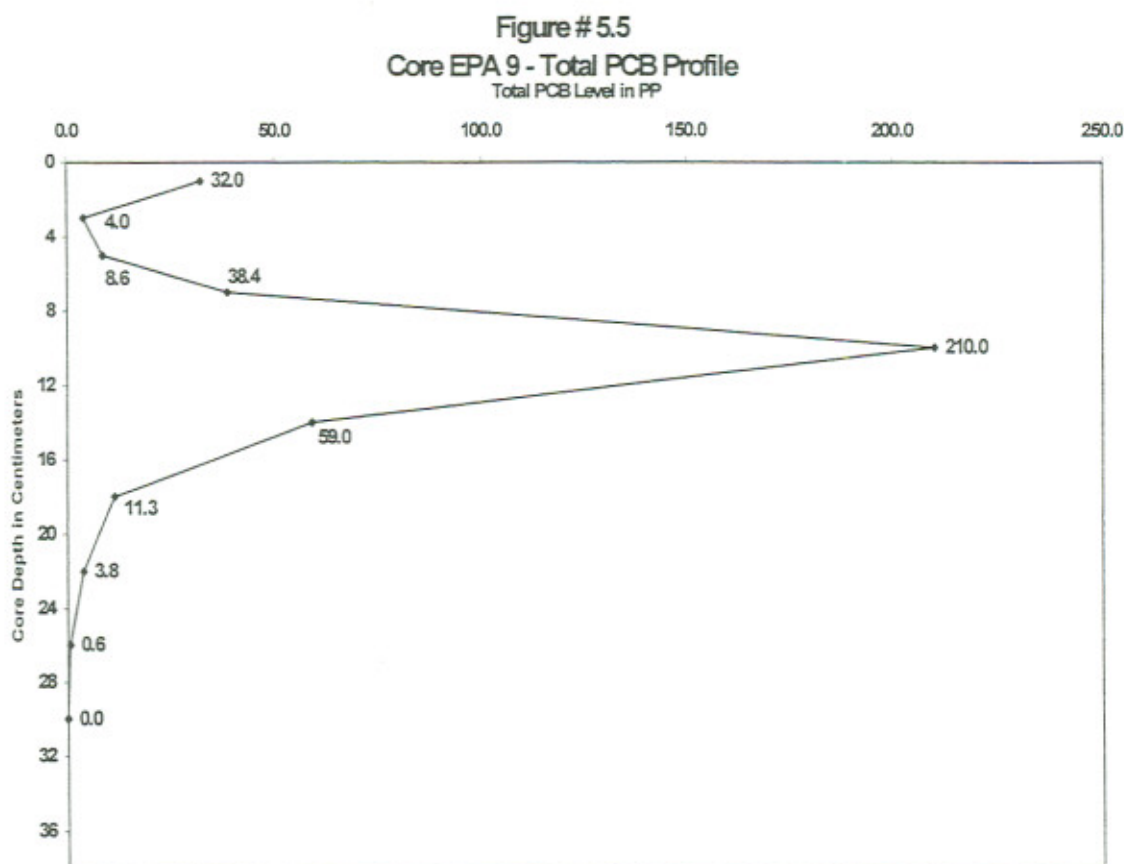
At site EPA 9 the peak contaminant levels have been reduced, most likely by mixing of the contaminants as they progressed over the vertical drop of the flight of Locks. Based on the Cs-137 profile in this area the deposition rates at this location are slower than were determined at site EPA 7, about 0.21 cm/year. This peak occurrence of Cs-137 appears in the duplicate sample analyzed in the 6 to 8 centimeter range.

The information provided by this profile does not readily coincide with the information found at site EPA 7. The initial detection of PCB that appears significant in the sediment appears in the 20 to 24 centimeter depth, with a peak concentration appearing in the core section at 8 to 12 centimeter depth. Based on extrapolation of the Cs-137 data, the initial occurrence of PCB would have appeared well before the historical

use of this compound, before the turn of the century. The more significant peak discharge apparent in the 8 to 12 centimeter range would correspond to approximately 1948. Based on the wide difference between core EPA 7 and EPA 9 it is doubtful that the dating information in this core is accurate. It is possible that water diversions through the lock structure or the nearby hydroelectric facility may have increased turbulence in the water column leading to the questionable results in this core. What is interesting is the correlation between the depths of the peak contaminant levels in both core EPA 7 and EPA 9. Both cores show initial introduction of the contaminant in the 20 to 28 centimeter depth range. At core EPA 7 which is upstream, the initial contaminant depth is in the 24 to 28 centimeter range while at core EPA 9 the depth is in the 20 to 24 centimeter range. This would be consistent with the downstream flow of contamination over time. It is also interesting that the sediment depth for the peak contaminant level is consistent, at the 8 to 12 centimeter level in both cores.

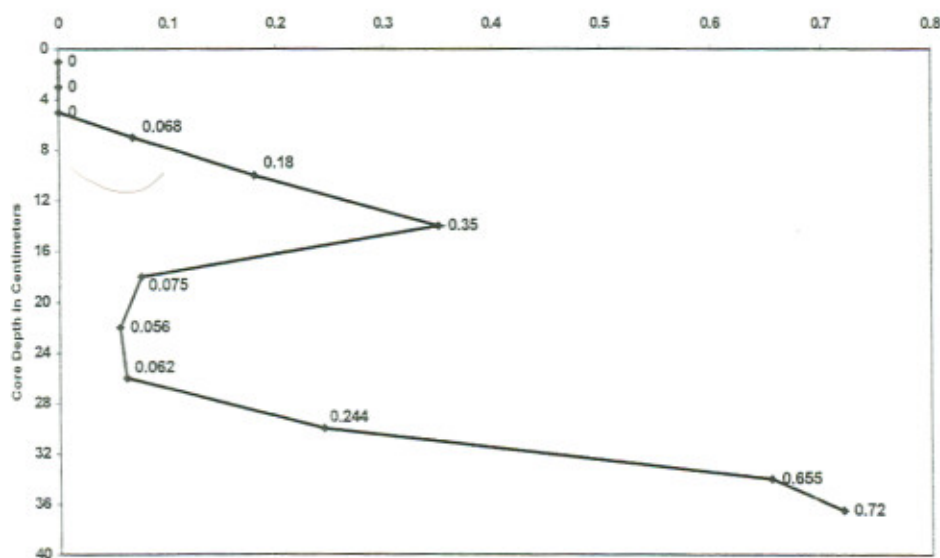
Figure # 5.6  
Core EPA 8 - Total PCB Profile  
Total PCB Level in PPM

At sample site EPA 8 the turbulence caused by vessel propellers in this location might have mixed up the sediments so that a contaminant profile was not identifiable. This core was also subjected to an evaluation of the sediment by core slice for PCB. Generally, this core shows the wide range of PCB contaminant mixing throughout the

vertical core striation. It is interesting how significantly lower the PCB concentrations are at this core sampling location, the highest concentration is well below 1 PPM total PCB.

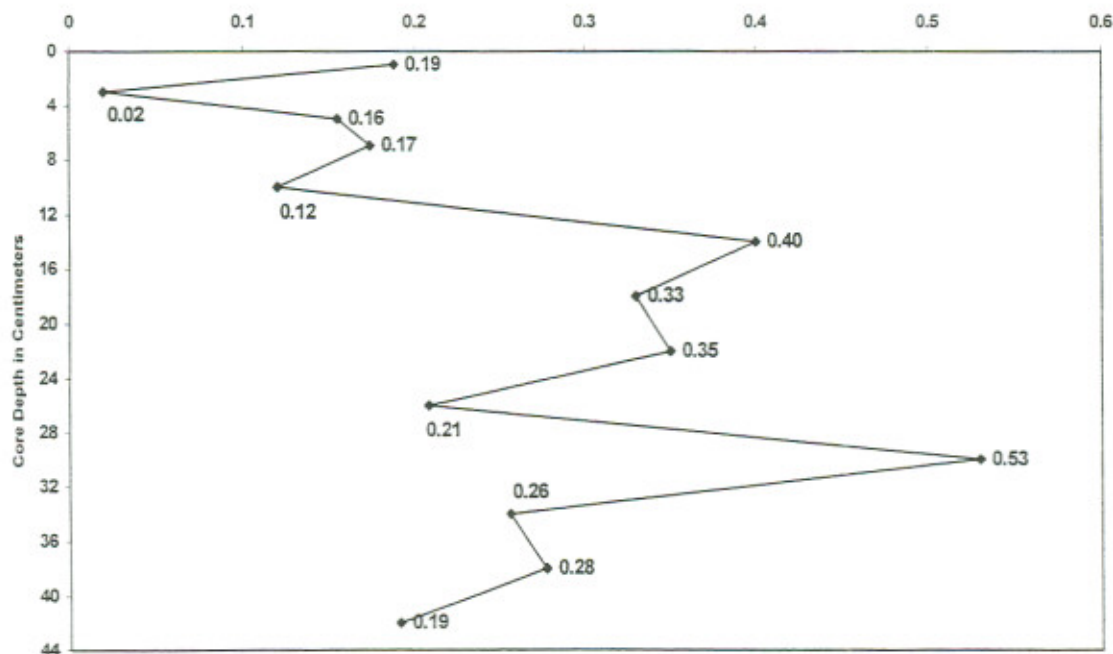
**Figure # 5.7**  
**Core EPA 21 - Total PCB Profile**  
Total PCB level in ppm

In Reach #4, the sample core collected at site EPA 21 exhibited a reasonable dating profile. This location was also evaluated for the vertical extent of PCB concentration. Peak occurrence of Cs-137 appears in the sample analyzed in the 24 to 28 centimeter range, based on this Cs-137 profile the deposition rates at this location are about 0.8 cm/year. The wide variation of PCB concentration through the core suggests that a relatively dilute source of PCB was discharging to the sediments over a long time frame. The peak concentration of PCB of 0.53 PPM would approximately equate to 1960, with a secondary peak of 0.40 PPM around 1980.

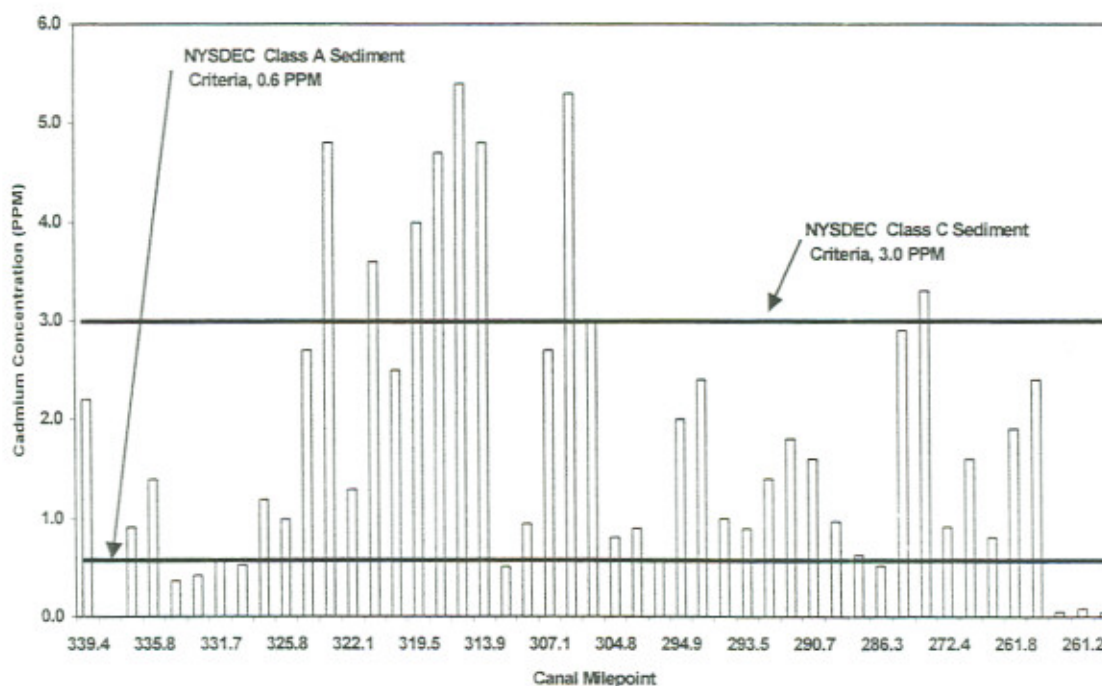
**Figure # 5.8**  
**Cadmium Concentration in Sediment**

Samples were collected and analyzed for mercury, cadmium and copper during the study. The results from these analyses were inconclusive and cannot be used to identify a contaminant source.

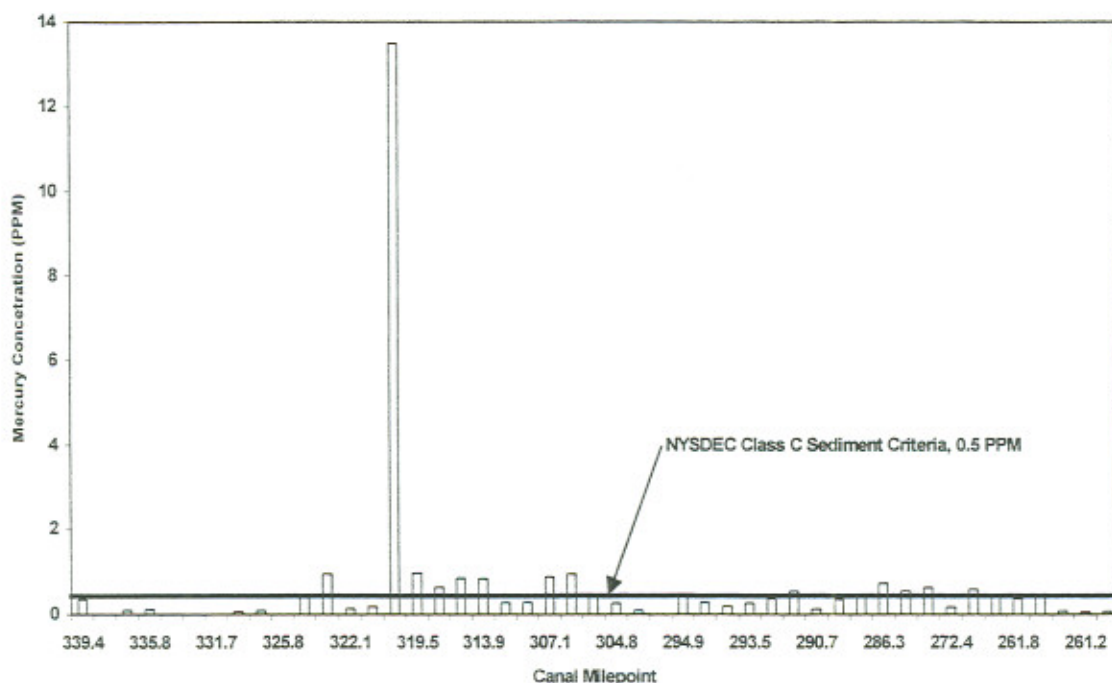
**Figure # 5.9**  
**Mercury Concentration in Sediments**

The general trend of mercury contamination within the canal sediment appears to be close to the NYSDEC class C sediment criteria level of 0.5 PPM for most of the canal between Lockport and the Genesee River with one major exception. That exception was found in core EPA 9 which was collected below the flight of locks in Lockport where the mercury concentration was 13.5 PPM. The first elevated levels of mercury was found at core location EPA 7 where the lower older sediments showed mercury at 0.94 PPM while the upper, newer sediments were below the 0.5 PPM threshold.
