# **Evaluation of Sediment Quality of the Erie Canal between the Niagara River and Rochester, New York**

**New York State Canal Corporation**

January 2000

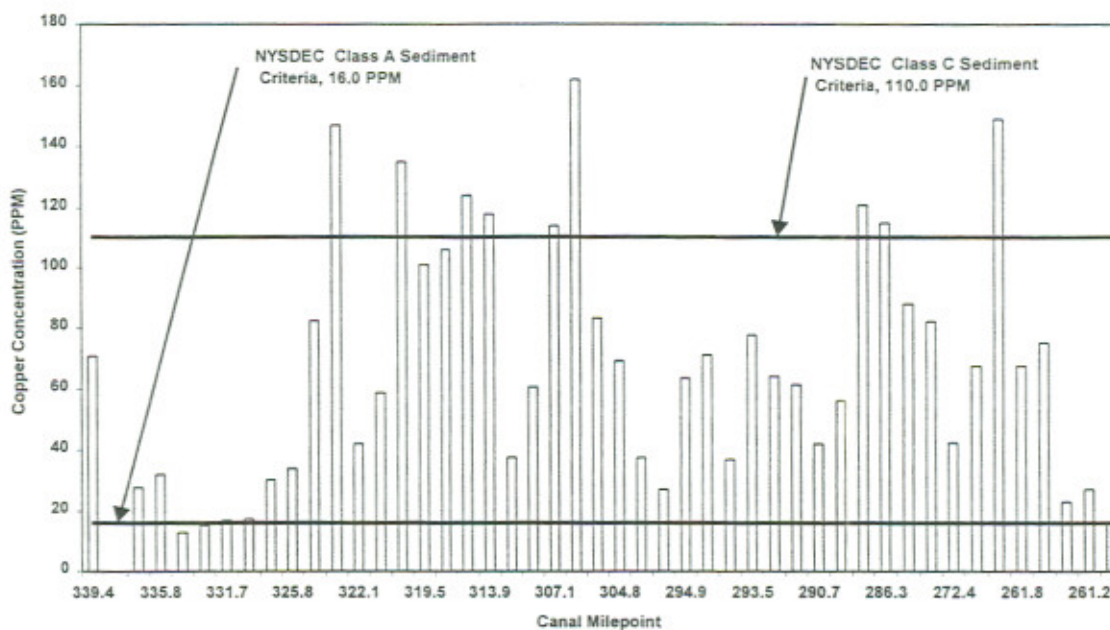
**Figure # 5.10**  
**Copper Concentration in Sediments**

The concentration of copper within the sediments generally showed the same trend as the level of cadmium in the sediments. Lower core sections also showed higher copper concentrations than the upper more recent core sections.

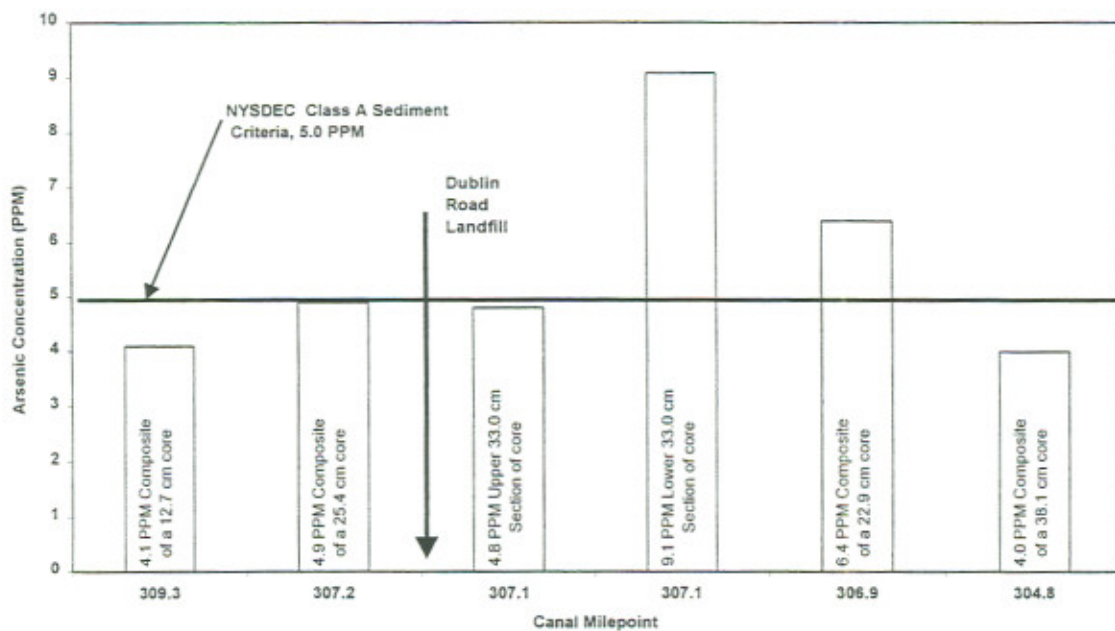
**Figure # 5.11**  
**Arsenic Concentration in Sediments**

An evaluation of arsenic contamination within the canal sediments seems to point to a historical discharge into the canal prism. The level of arsenic in the deeper sediments Immediately below the former Dublin Road landfill are nearly double the NYSDEC threshold for this contaminant.
