# Remedial Investigation Report

**Eighteenmile Creek Corridor,  
Lockport, Niagara County, New York  
Site Number 932121**

**September 2006**

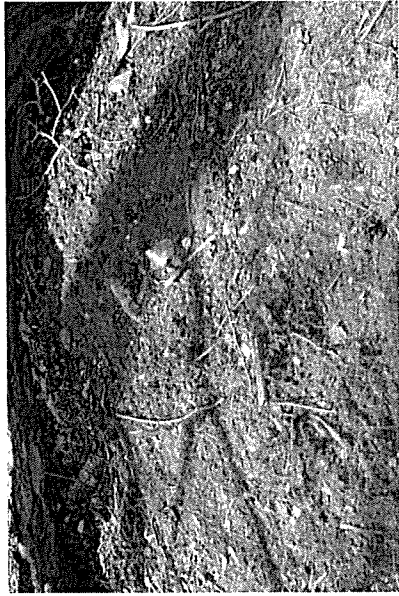
Figure 5-1. Photograph of ash from a small ridge along Eighteenmile Creek. This area was the location of sample SS-3. Photograph taken by Paul Dicky on April 16, 2002.

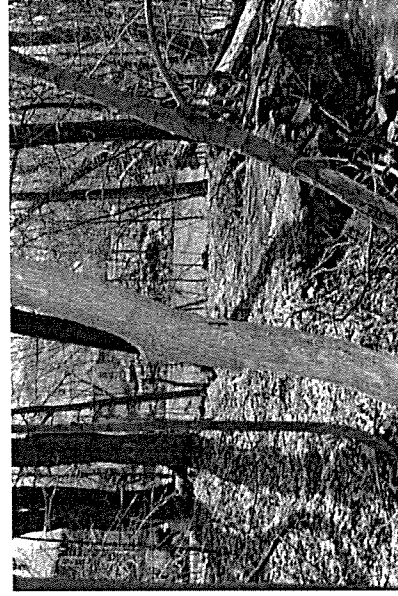
Figure 5-2. Photograph of the small ridge of ash fill along Eighteenmile Creek. The grassy area in the background is the side yard of the property at 143 Water Street. Photograph taken by Paul Dicky on April 16, 2002.

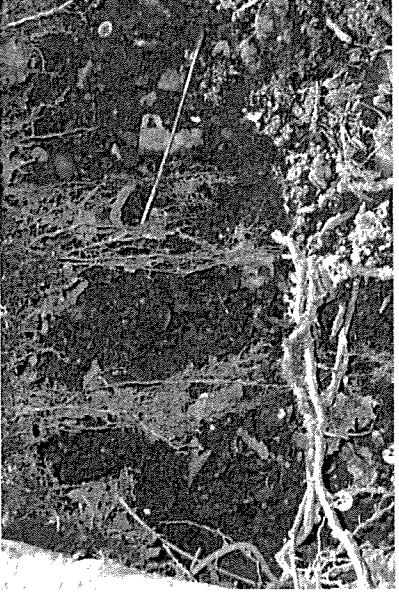
Figure 5-3. Closeup photograph of ash fill in the creek bank along Eighteenmile Creek. Observe the buttons, which are characteristic of the ash fill on the island of the former Flintkote property. Photograph taken by Paul Dicky on April 16, 2002.

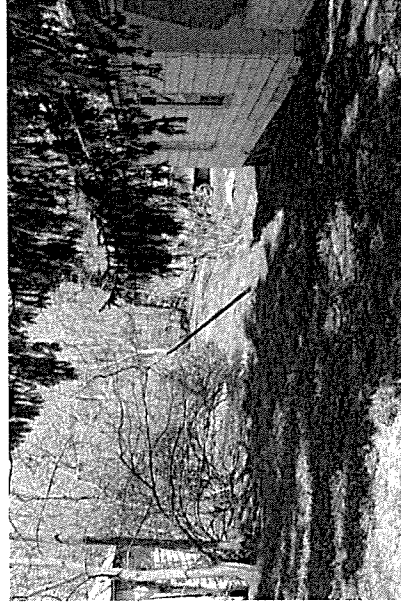
Figure 5-4. Photograph of the property line between 131 and 127 Water Street. The elevation difference (about 3 feet) delineates the extent of ash-cinder fill at the 143 and 131 Water Street properties. Photograph taken by Paul Dicky on April 16, 2002.

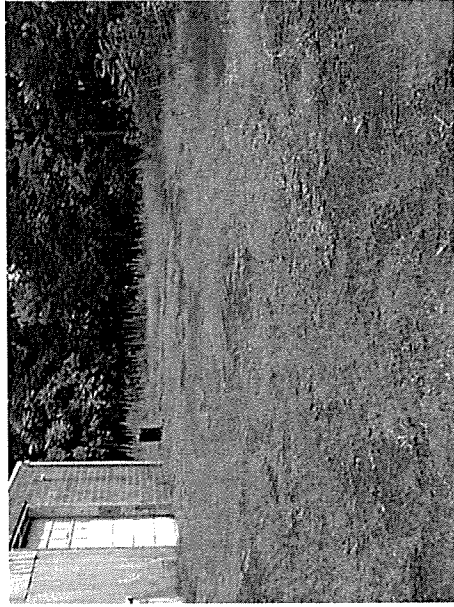
Figure 5-5. Photograph of the slag and cinder fill on the White Transportation property. Photograph taken by Glenn May on September 22, 2005.

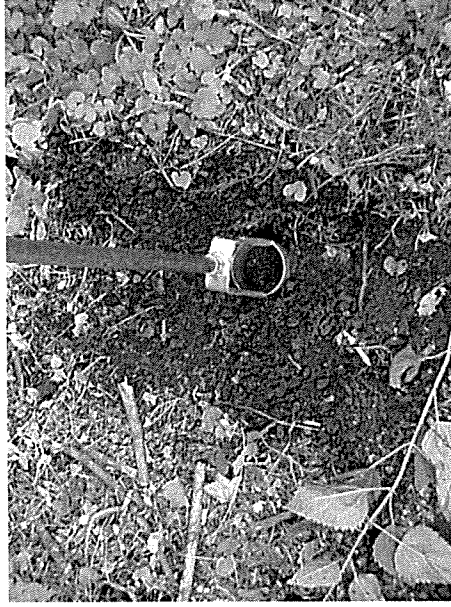
Figure 5-6. Closeup photograph of the slag and cinder fill on the White Transportation property. Photograph taken by Glenn May on September 22, 2005.

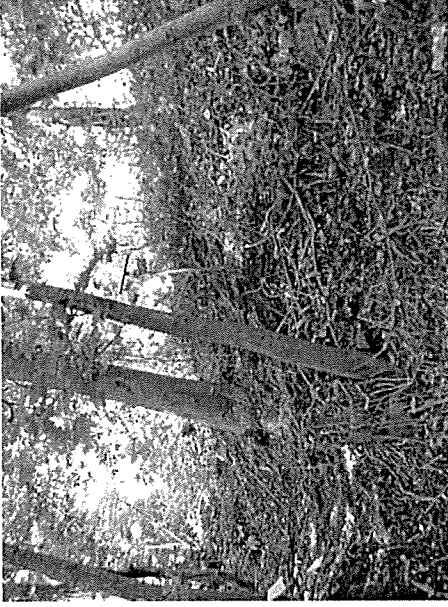
Figure 5-7. Photograph of the ash-like fill along the north bank of Eighteenmile Creek in Upson Park. Photograph taken by Glenn May on September 22, 2005.

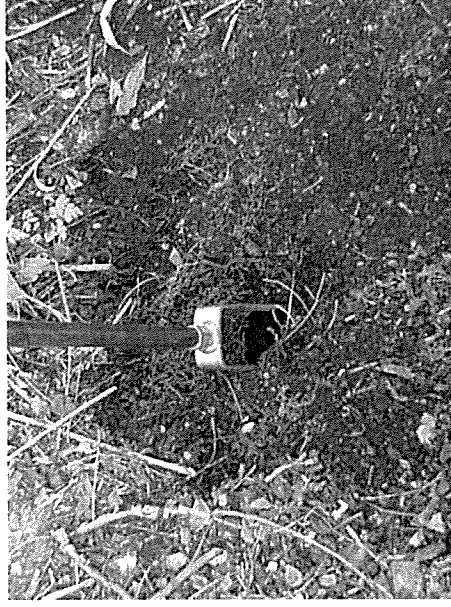
Figure 5-8. Closeup photograph of the ash-like fill along the north bank of Eighteenmile Creek in Upson Park. Photograph taken by Glenn May on September 22, 2005.

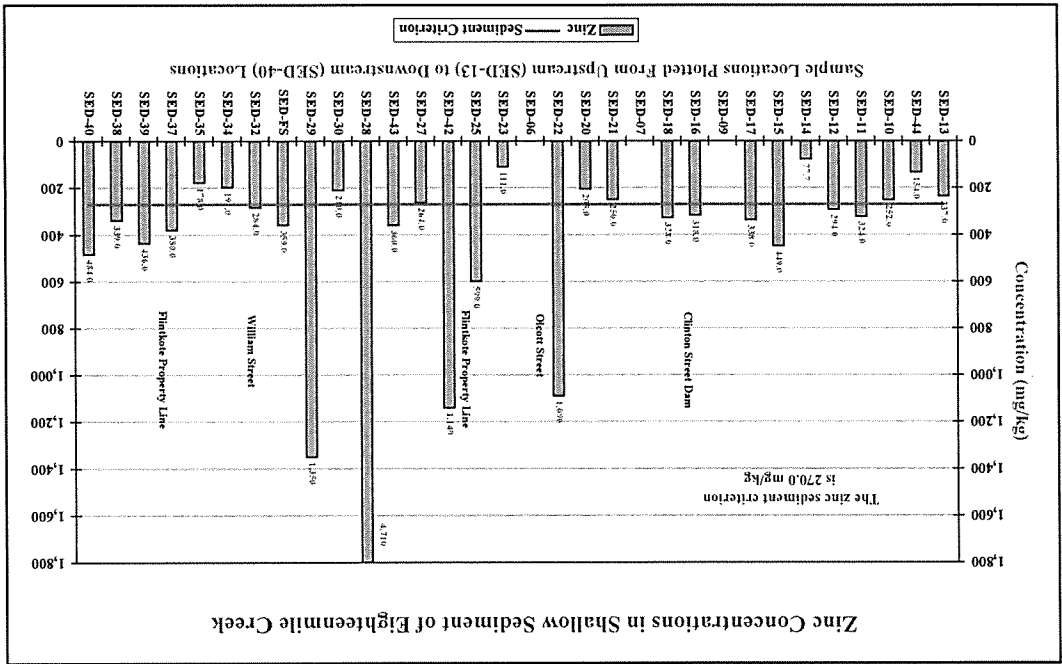
The sediment zinc results are shown graphically in Figures 6-11 and 6-12, and are plotted from upstream to downstream locations to show spatial variability. These figures show that thirty-seven of fifty-seven sediment samples collected from Eighteenmile Creek between the New York State Barge Canal and Harwood Street contain zinc at concentrations that exceed the NYSDEC sediment criterion. Eleven of these

Figures 6-11 and 6-12 also show that sediment in Eighteenmile Creek between the New York State Barge Canal and the Clinton Street dam, with the exception of the deep sample collected from the SED-15 location, contains zinc at concentrations below 1,000 mg/kg. The relatively low level of zinc contamination in this stretch of the creek appears anomalous, however, considering the high concentrations of zinc in fill from Upson Park (2,950 to 7,870 mg/kg; Table 5-12). It is possible that deeper sediment is more contaminated with zinc, or that the relatively swift currents in this portion of the creek have carried zinc contaminated sediment and fill further downstream. The latter scenario may explain the higher concentration of zinc in the deep sample collected from the east side of the mill pond (SED-15), which is a depositional area. It is also possible that this contamination results from an unknown source of zinc on the east side of the mill pond on the former United Paperboard Company property.

Three of eleven sediment samples collected between the Clinton Street dam and the Former Flintkote Plant Site, and seven of twenty-two sediment samples collected from Eighteenmile Creek adjacent to the Former Flintkote Plant Site, contain zinc at concentrations above 1,000 mg/kg (Figures 6-11 and 6-12). Fill samples collected from the former United Paperboard Company property and the Former Flintkote Plant Site contained zinc at concentrations ranging to 1,640 mg/kg (Tables 5-14 and 5-15) and 21,900 mg/kg (Table 6-1), respectively, suggesting that these properties are a significant source of zinc to the creek and millrace. The elevated concentrations of zinc in sediment downstream of the Flintkote property are likely caused by sediment transport from the millrace.

Figure 6-11. Zinc concentrations in shallow sediment of Eighteenmile Creek from the New York State Barge Canal (SED-13) to Harwood Street (SED-40). A scale was selected that best presents the data at lower concentrations. The blanks indicate that the sample was not analyzed for zinc.

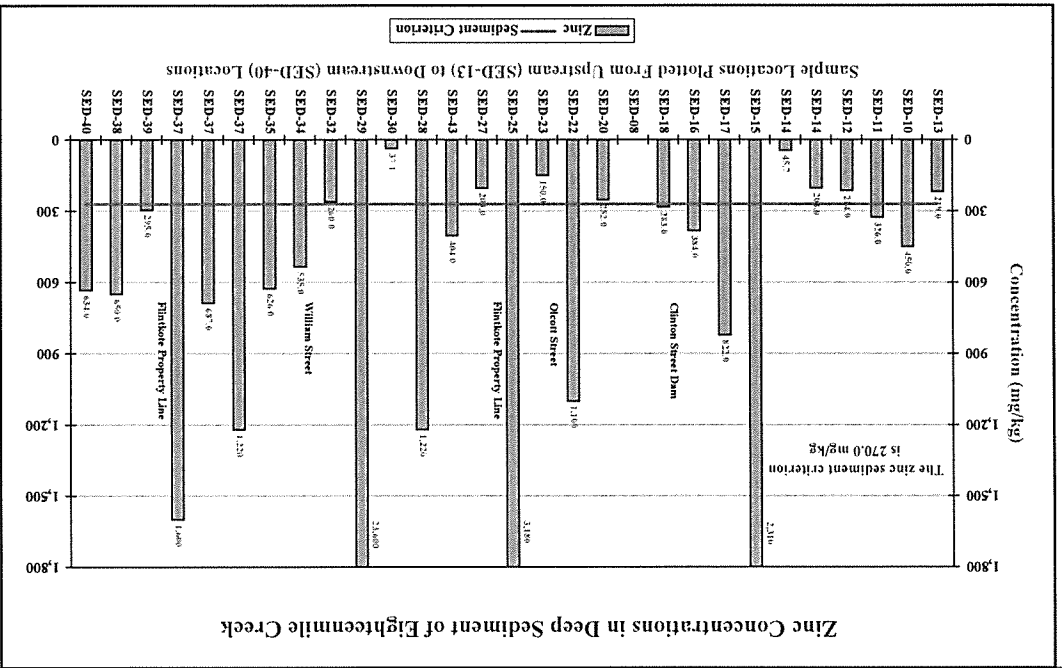
Figure 6-12. Zinc concentrations in deep sediment of Eighteenmile Creek from the New York State Barge Canal (SED-13) to Harwood Street (SED-40). A scale was selected that best presents the data at lower concentrations. The blanks indicate that the sample was not analyzed for zinc.
